DRAGONBOARD- Wall & Ceiling Projects

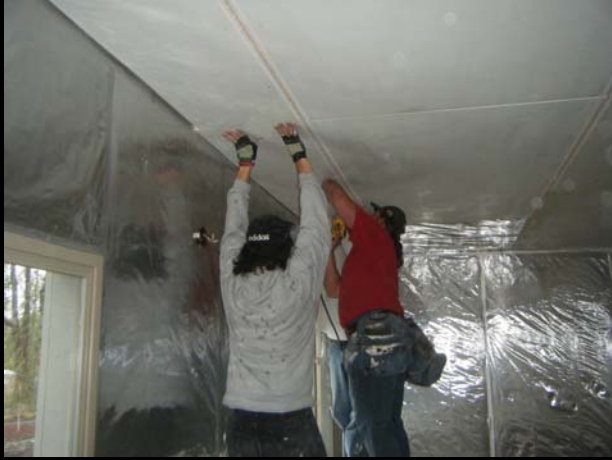
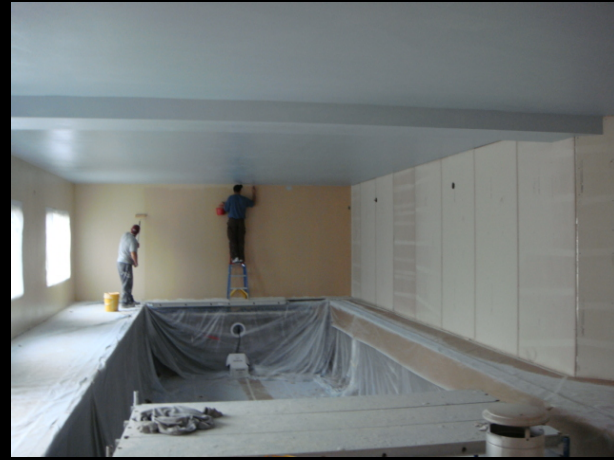
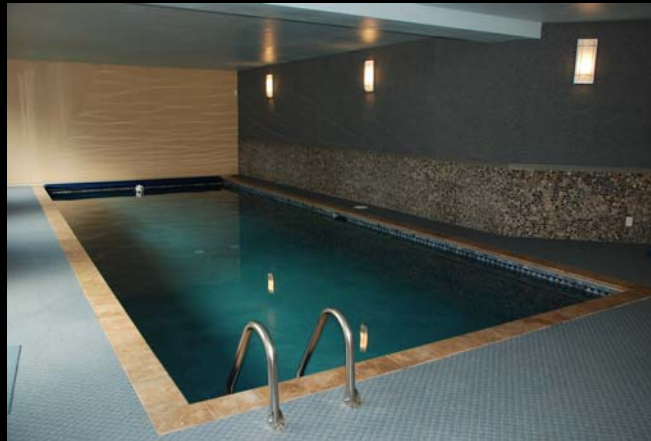
The builder specified DragonBoard in the swimming pool area to minimize mold issues and to provide a high impact, long lasting enclosure. The entire room was first sealed with Alumiseal, a mylar/aluminum product to minimize vapor seepage to the house. One wall was installed "rough side out" to facilitate the stone & carpet application (the carpet was glued and the stone was applied similar to tile). The remainder of the walls were finished with epoxy paint because of the wet environment. The builder also utilized DragonBoard in the wood shop and garages to improve impact resistance as well as provide a two-hour firewall.
